Woodpeckers Prompt Shift in Roofing TPO

Wind and birds cause turmoil atop Arizona school.

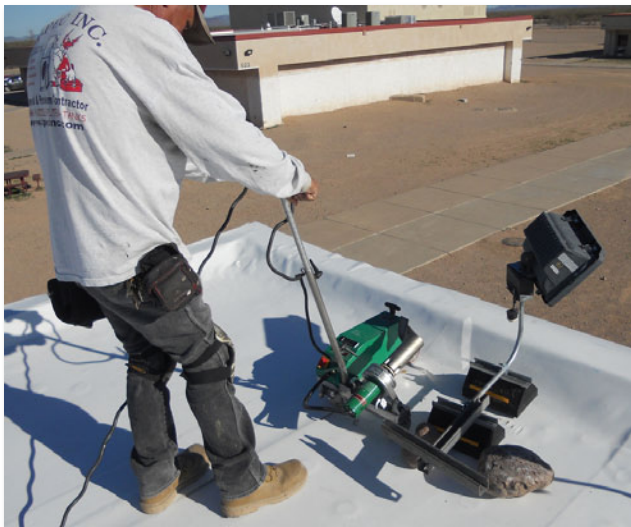
A contractor seals the seams in San Simon's new roofing TPO which is not appealing to woodpeckers that had damaged the previous TPO.

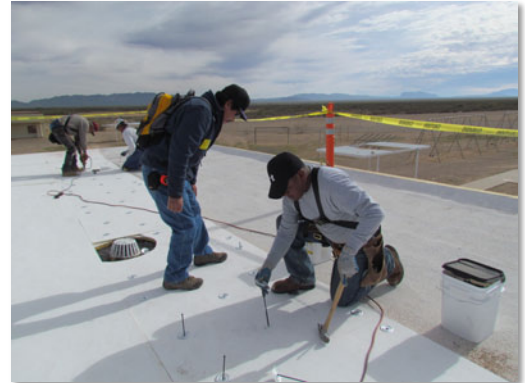
Western Region General Engineer Michael Redhair (center) examines screw patterns in a new roof at San Simon Elementary School in Arizona while ensuring that the dense roofing boards are not spongy or springy. Meanwhile, a roofing contractor makes sure the screws are reaching down to the metal decking.
